Learn from the mistakes of others; you'll not live long enough to make them all yourself . . . Issue 3/2004

When Night VFR and IFR Collide

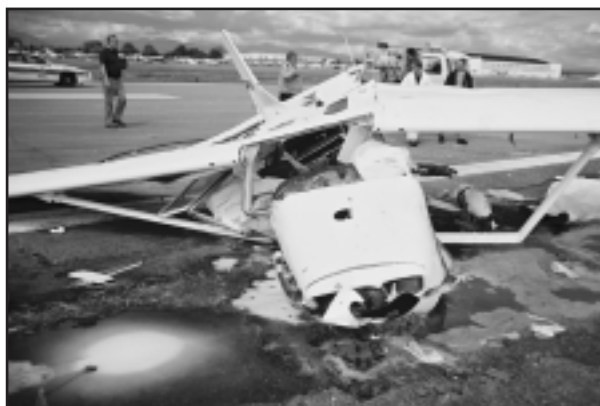
TSB Final Report A02P0136—Aircraft Stalls on Takeoff

On July 1, 2002, a rented Cessna 172N was taking off from Boundary Bay Airport, British Columbia, at 12:14 Pacific Daylight Time (PDT), with the pilot and three passengers on board, for a local pleasure flight. The takeoff on Runway 25 appeared to be normal until the main wheels left the ground, whereupon the nose rose to a very steep attitude. The aircraft climbed to an estimated height of 100 to 150 ft, the right wing dropped, then the left wing, then the right wing again, and the aircraft struck the runway nose down and right wing low. A fire broke out in the area of the left cowling, fed by a broken fuel line from the left fuel

tank, but was quickly extinguished by bystanders with portable fire extinguishers. Two passengers were fatally injured, the pilot sustained serious injuries, and the third passenger died in hospital the next day. The aircraft was destroyed.

4. The aircraft was overweight at takeoff; it is unlikely a weight and balance calculation was completed prior to flight.
5. The aural stall warning mechanism was defective and probably did not activate when the aircraft stalled during the accident sequence.

6. The wrong flap selector plate for the particular Cessna 172 model was installed around the cockpit flap lever, which limited flap extension to a maximum of 30°.

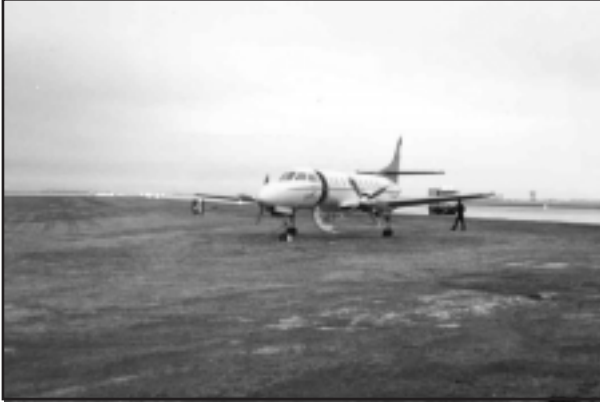
TSB Final Report A02C0072—Runway Excursion

On April 16, 2002, a Swearingen SA226-TC Metro II was on a scheduled flight, under instrument flight rules (IFR), from St. Theresa Point to Winnipeg, Manitoba, with two pilots and 13 passengers on board. The crew was anticipating a visual approach to Runway 36 at Winnipeg International Airport but, because of conflicting traffic, accepted vectors for the instrument landing system (ILS) approach to Runway 13. At approximately 19:08 Central Daylight Time (CDT), the aircraft landed to the right of the runway centreline, then drifted further right and departed the runway surface, damaging a runway edge light, a taxiway edge light, and a runway identification sign. It then travelled 1 150 ft through the infield and came to rest near the intersection of Runways 13/31 and 18/36. There were no reported injuries. The aircraft's left engine (Garrett TPE 33) sustained damage from ingested mud and vegetation. The right wing, left wing, and fuselage were damaged when the aircraft struck the edge lights and the runway identification sign. After the aircraft stopped, the crew shut down the engines and advised the Winnipeg Airport air traffic controller of their position. The airport crash alarm was activated and emergency response personnel responded.

1. The aircraft landed during heavy precipitation on a wet runway, and it likely hydroplaned, resulting in a loss of directional control and runway excursion.
2. The aircraft was cleared, on short notice, for an approach to a runway with a tailwind that exceeded MANOPS guidelines for operations on a wet runway, and was cleared to land with a crosswind that approached the limit in those guidelines.
3. The crew continued with an instrument approach in rapidly deteriorating weather conditions characterized by heavy rain, low visibility, wind shear, turbulence, and tailwind and crosswind components.

Safety action—After the occurrence, the operator added a crew resource management (CRM) segment to its training program for Metro pilots.

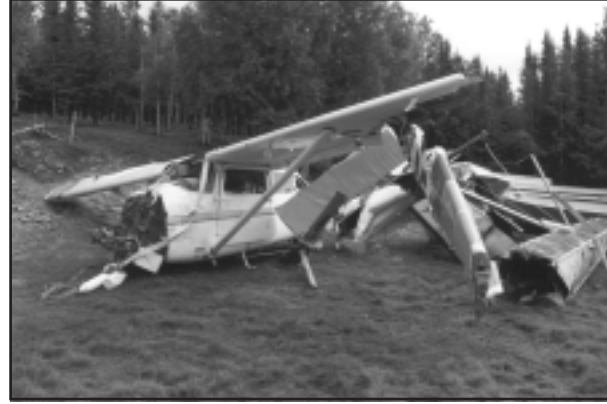
TSB Final Report A02C0145—Collision with Water

On June 29, 2002, at approximately 14:10 Central Standard Time (CST), a Cessna A185F seaplane was taking off from Engemann Lake, Saskatchewan, on a visual flight rules (VFR) flight to Thomson Lake, with a pilot and two passengers on board. The aircraft was about 10 to 15 ft above the water, established in a wings-level, nose-up climb attitude, when the pilot glanced to the left. Before the pilot was able to look back to the front, the aircraft struck the water, overturned, and began to sink. The pilot and front-seat passenger escaped from the sinking aircraft and survived. The second passenger, who was in the left rear seat directly behind the pilot, sustained serious injuries to the legs, chest, and head during the impact, did not escape from the aircraft, and drowned. The aircraft was substantially damaged. The accident occurred during daytime visual meteorological conditions (VMC).

1. The eye bolt from the upper left forward float strut attachment had a pre-impact fatigue crack greater than 75% of the cross section of the eye bolt.
2. Injuries sustained by the rear seat passenger likely prevented his escape from the sinking aircraft. The risk of injury was increased because the seat was not equipped with a shoulder harness.
3. The pilot's rest period the night before the accident was less than the minimum required by either the *Canadian Aviation Regulations* (CARs) or the company operations manual. △

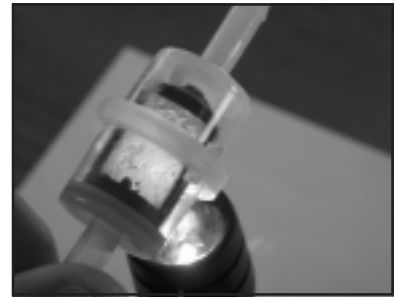
The owner of a Challenger ultralight aircraft had used over 6 400 litres of a 50:1 mixture of Shell Gold Premium fuel and Quaker State TC W3 oil, without a problem. In January, he decided to use a new fuel mixture using synthetic instead of mineral oil in his Rotax 503 DCDI engine (dual carburetor and dual ignition). Immediately following this change, he experienced the first of several in-flight engine failures caused by fuel starvation. Inspection of the fuel filter revealed a gold coloured jelly-like substance blocking the screen of the Kimpex 07-245 filter. This prevented the fuel from reaching the carburetors. Fortunately, the engine failures did not result in a forced landing because the aircraft was equipped with a parallel electrical fuel delivery system that the pilot activated to restart his engine.

In subsequent flights, it was necessary to replace the filter four times because of repeated contamination by the jelly-like amber coloured substance. He noted that it was of a colour similar to the synthetic oil that he was using. In order to find the cause of this chemical substance, the pilot decided to do some experimenting on the ground. First, he had to determine that it would occur, so he set-up a 25-L Jerrycan of a 50:1 mixture of new fuel and oil identical to the one he used in flight. He installed a Kimpex filter and a length of clear 5/16-in. fuel line between another similar container. He transferred the mixture from one container to the other, using a 2-5 psi pump, in temperatures similar to those he encountered in flight; approximately -20°C. He obtained the same results, a significant presence of an amber-coloured goo or slime in the filter screen. He repeated the experiment several times. The

manufacturer was asked to proceed with similar tests, but has been unable to reproduce the same results. The fuel filter blockage only occurred when the pilot switched from a mixture of fuel and mineral oil to one with synthetic oil.

As an aircraft owner, your responsibility is to ensure that the fuel and oil you use is of a type recommended and approved by your aircraft engine manufacturer. If any of you have experienced similar situations, we would like to hear from you. Please e-mail me at beauchs@tc.gc.ca. Thank you. ✈️
